**REPAIR COUPLING INSTRUCTION MANUAL FOR 8mm
THERMOPLASTIC HIGH PRESSURE FOG LATERAL**

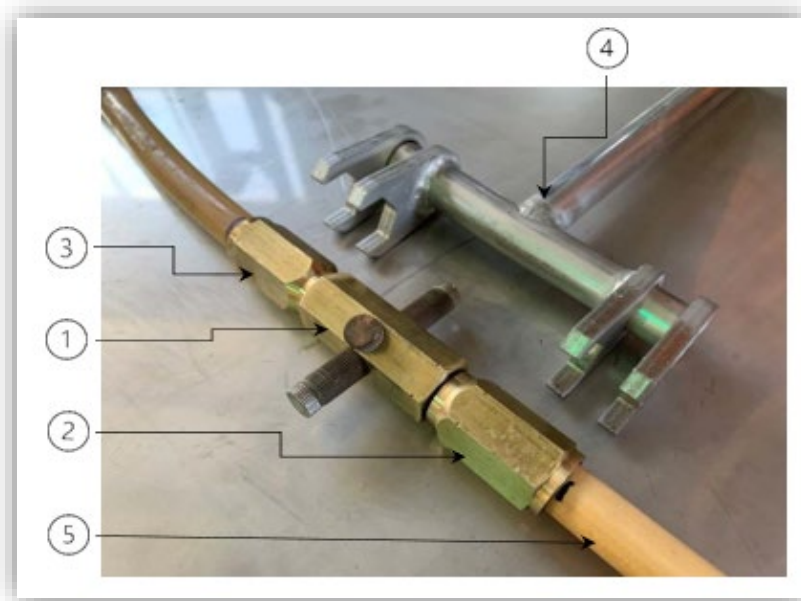
No.	Part	Material
1	Fog Connector Body	C268 Brass-Copper Alloy
2	Swage Nut Left Hand	C268 Brass-Copper Alloy
3	Swage Nut Right Hand	C268 Brass-Copper Alloy
4	Swage Nut Spanner	SS 304
5	Thermoplastic HP Hose	SAE 100R7

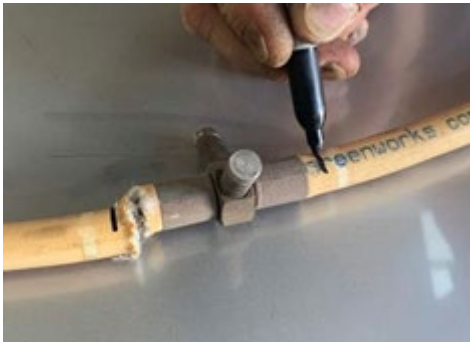
1.

The Repair Coupling will replace 55mm of HP FogLateral. Mark either side of the failed swaged connector.

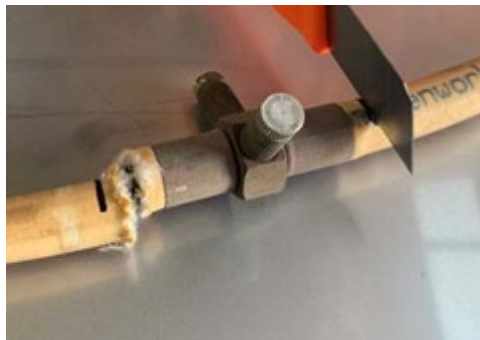
2.

Using a sharp knife cut out the section to be replaced.

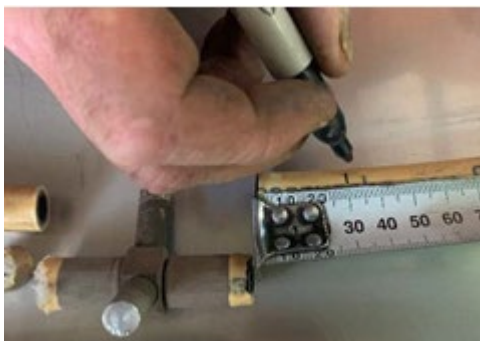
Scribe a witness mark 30mm down from both cut ends.

Screw Swage Nuts onto both hose ends to the depth of the witness marks made in step 3.

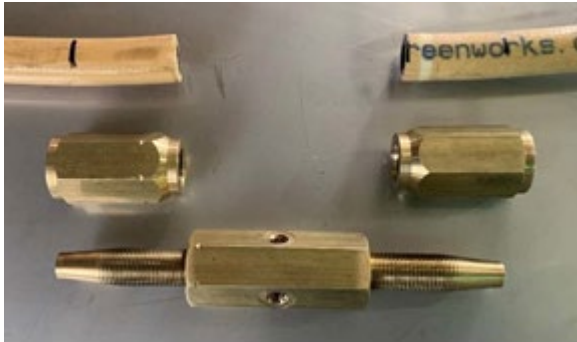
4.

Disassemble the Repair Coupler, keeping note of the witness notches on the left hand threaded items.

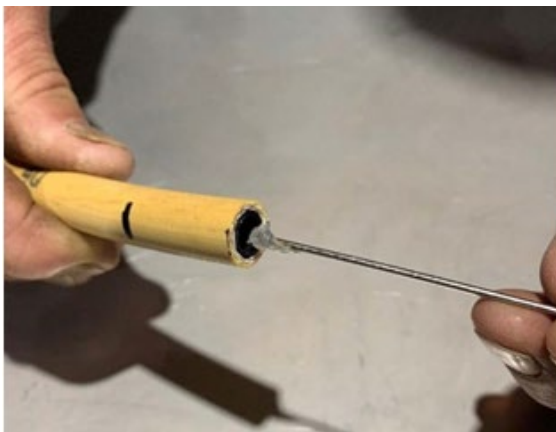
5.

Apply water based lubricant to the inside **only** of both thermoplastic hose ends.

Common cause for this to occur is insufficient lubrication was used inside the thermoplastic hose (step #5) and /or on the end male thread (step #7)

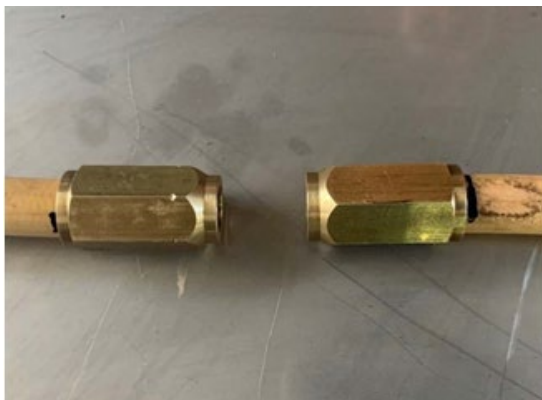
6.

NOTE: NO lubricant is to be used on the outside surface of the thermoplastic hose or inside the Swage Nuts.

Once the Repair Coupling is fully screwed together check that both witness marks on the thermoplastic hose are against the Swage Nut as in step #6. If the gap has grown by less than 1 mm the assembly is complete.

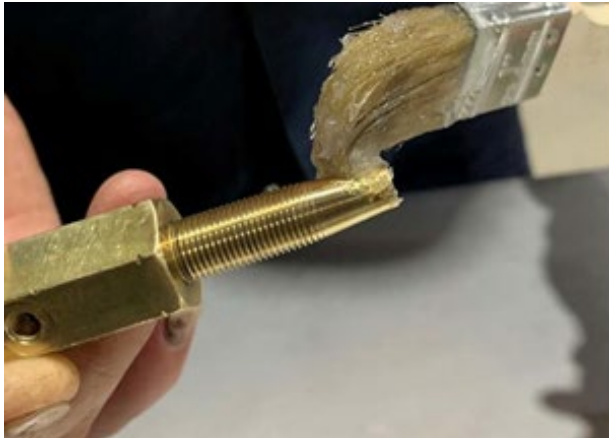
7.

Apply water-based lubricant to the tapered ends of the male threaded sections of the Repair Coupler Body.

NOTE: DO NOT place lubricant on the Thread

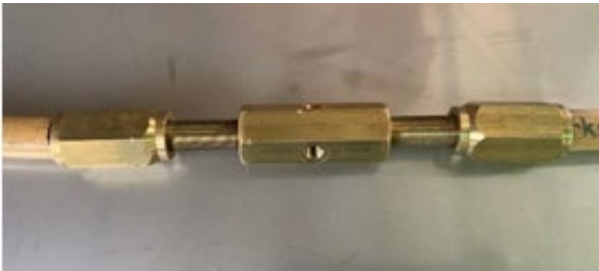
8.

Fit Repair Coupler body tapered ends into Swage Nuts noting that the left-hand thread NOTCHES are aligned for the Nut and Body.

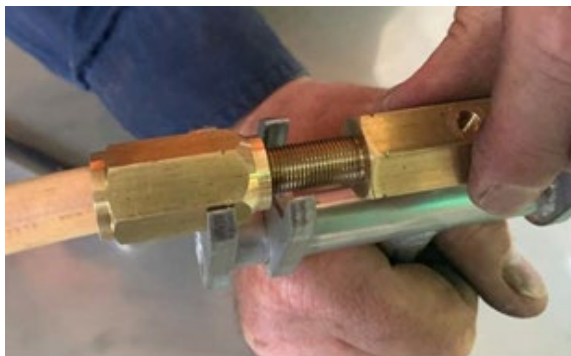
9.

Rotate the Repair Coupling Body by hand to get it started.

NOTE: Making the repair to the fog lateral in situ, you will need to spread the Swage Nuts to fit the Repair Coupling body. This is a benefit as it will apply end thrust to the Swage Nuts while screwing the Repair Coupling body into the Swage Nuts.

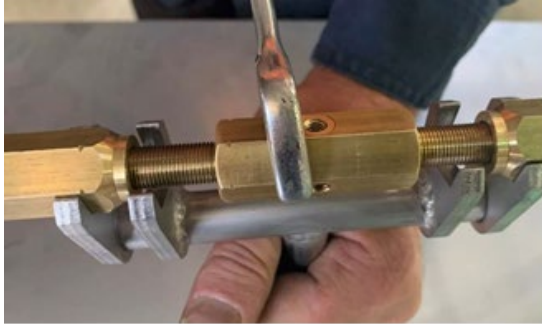
10.

Prior to using the 19 mm spanner to screw the Repair Coupling together, measure the gap between the Repair Coupling Hex body and the Swage Nut, if the gap differs more than 1 mm unscrew the body until you feel it clicking as the start of the threads ride over one another, once this is happening in both Swage Nuts you can revert back to screwing the Repair Coupling together. Please check the gap again.

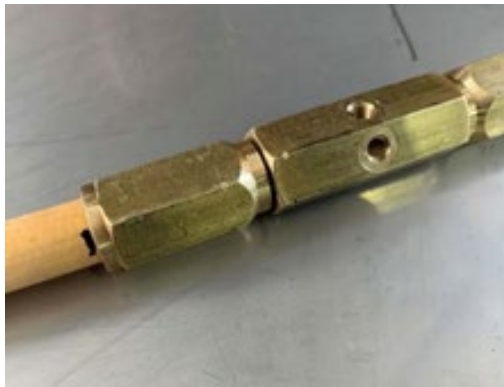
11.

NOTE: If greater than 1mm you will need to disassemble the Repair Coupling and start the process again from step #5.

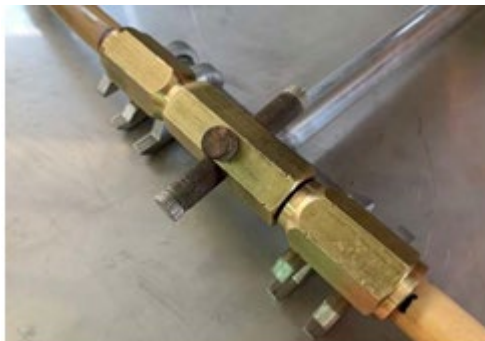
12.

Once the Repair Coupling installation is complete fit the two Fog Nozzles and one plug, then using the spanners rotate the Repair Coupling body to align the Fog Nozzles on the Repair Coupling to those on the HP Fog Lateral.
